P. L. 93-251 SECTION 32 DEMONSTRATION
PROJECTS STUDY

MRD HYDRAULIC LABORATORY SERIES
REPORT NO. 8
PRELIMINARY

PRELIMINARY LABORATORY INVESTIGATION
OF SECTION 32 HARD POINT

U. S. ARMY ENGINEER DISTRICT, OMAHA
MISSOURI RIVER DIVISION, OMAHA
OCTOBER 1978

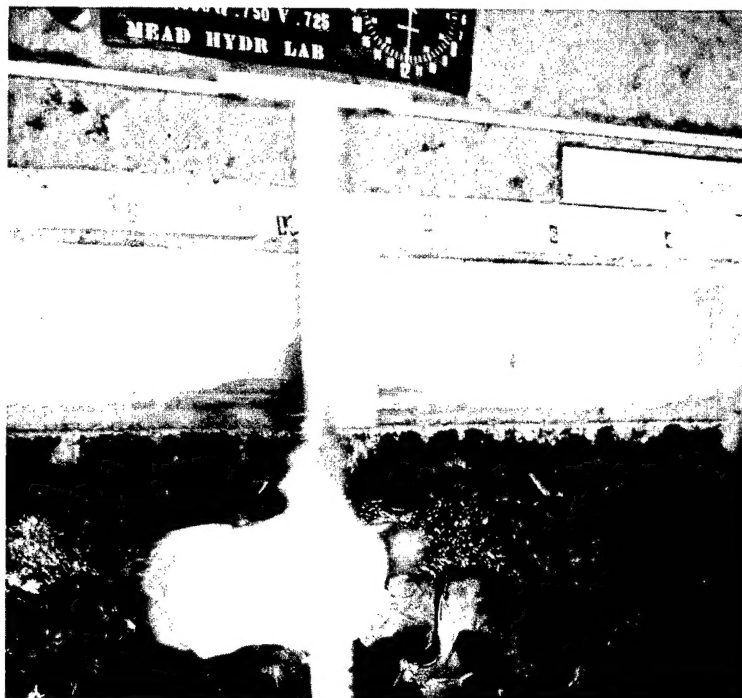
Photograph 1. Leveling test bank by using a male template fixed to a carriage on a rail traverse.

1. The channel bank in the test area was completely rebuilt before each test. It was shaped to the desired configuration by pulling a male template back and forth across the bank material. See photo 1. The template was mounted on a carriage which rolled along a system of uniform elevation railing. This resulted in a berm with a top elevation of 1.500 feet, a top width of 1.6 foot, a length of 20 feet, and a bank slope of 1 vertical to 2 horizontal.

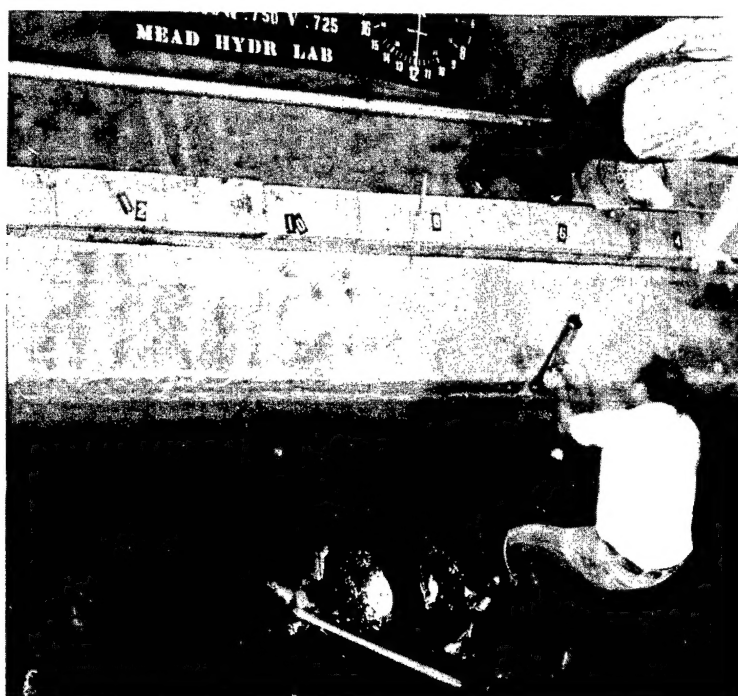
Photograph 2. Excavation of the root trench into the right bank.

2. A trench for the hard point root was then cut in the bank and the rock structure was built by placing the crushed limestone riprap into the trench. See photo 2.

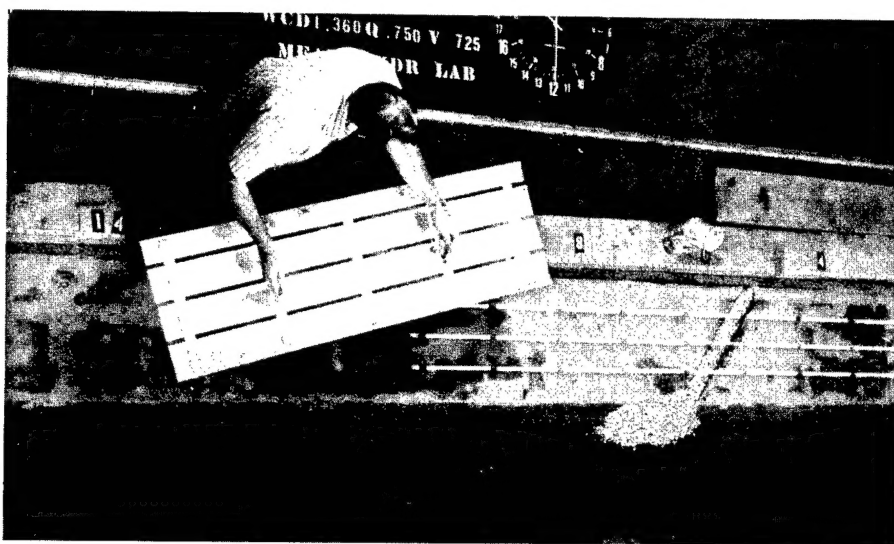
Photograph 3. Marking procedure for the horizontal reference lines on the test bank. Note hard point structure in place.

3. The berm was then gridded with .05 ft. wide lines using a white powder. The grid lines were spaced 1.0 ft. by 0.4 ft. with the larger spacing parallel to the channel. This grid system served as a reference to measure bank erosion while the model was in operation. See photo 3.

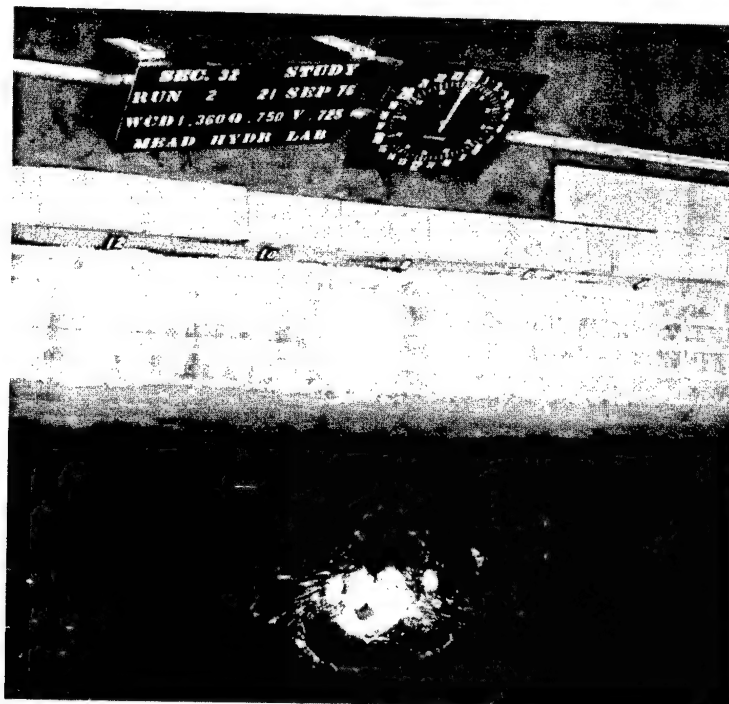
Photograph 4. Test bank arrangement prior to run 2. Notice that this run had no hard point structure.

Test run 2 had no hard point structures positioned in the right channel bank. This run was used to determine the amount of bank area which would be removed by erosion without any type of protection. At the upstream end of this run (station 1.7), the flow expanded off the end of the fixed rock revetted slope and caused the right bank erosion to extend to station 6.5. See photos 4 and 5 and plate 2. Station 6.0 was, therefore, selected as the location for the various hard point structures in the forthcoming model tests.

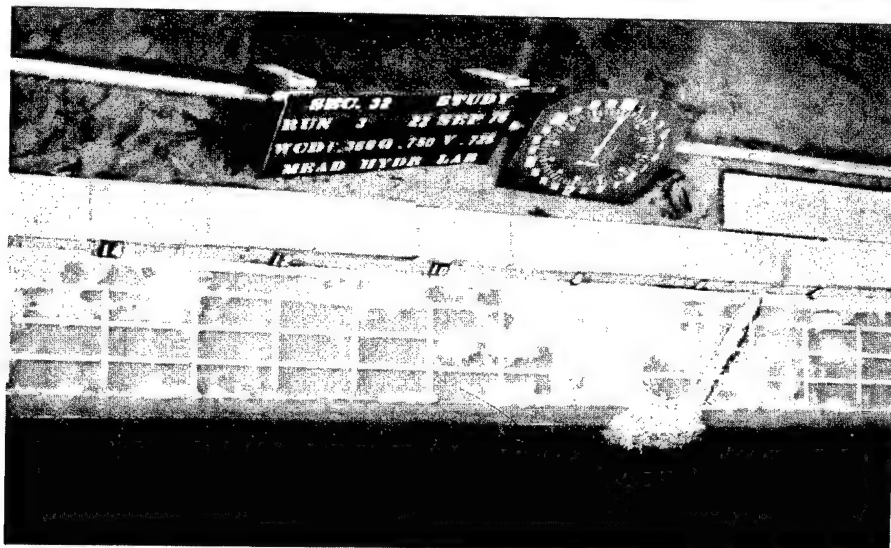
Photograph 6. Test bank arrangement prior to run 3.

The layouts of the different hard point structures are shown on plate 2 and in photographs 6 through 17. For test runs 3, 7, and 8, the hard point structures were constructed out to the edge of the channel bank. For test runs 4, 5, and 6, the hard point structures were extended 0.5 foot further into the channel. This was done in an attempt to determine if this would decrease the amount of bank erosion which occurred downstream from the hard point structures.

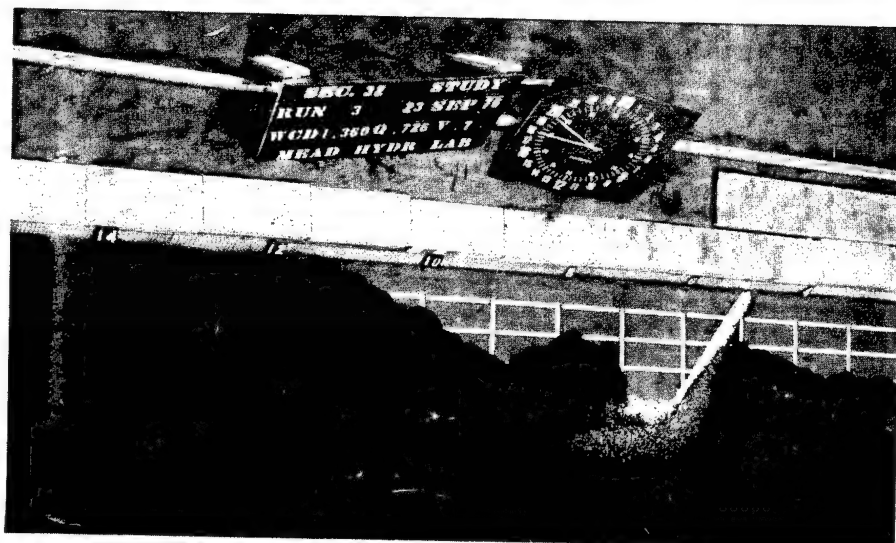
Photograph 7. Resulting channel bed and bank configurations at the end of run 3.

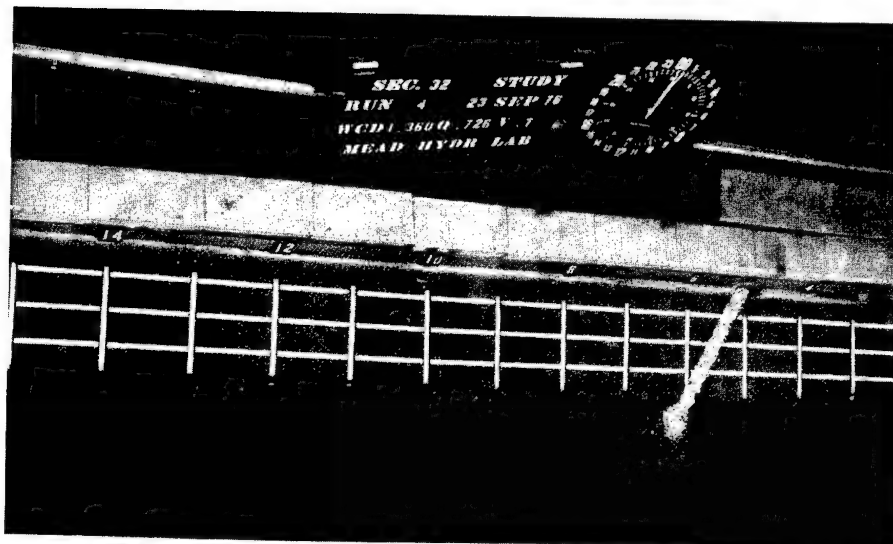
Photograph 8. Test bank arrangement prior to run 4.

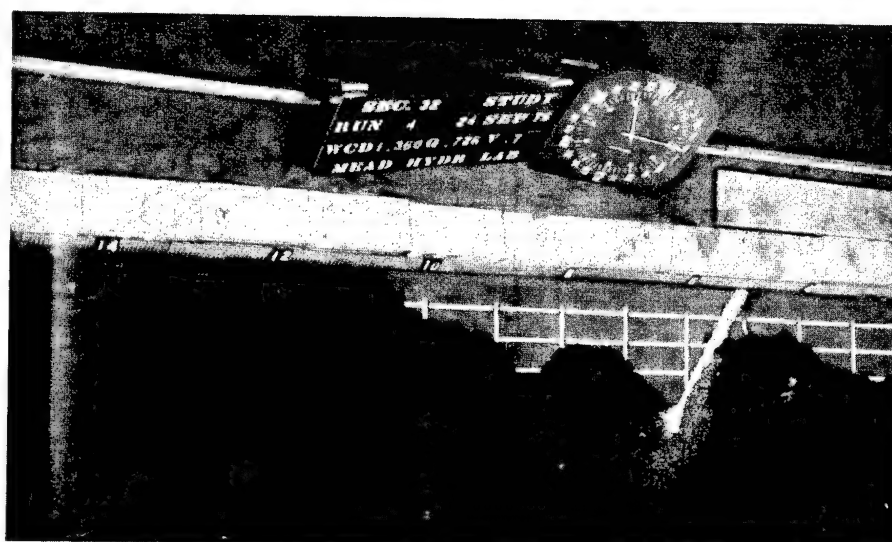
Photograph 9. Resulting channel bed and bank configurations at the end of run 4.

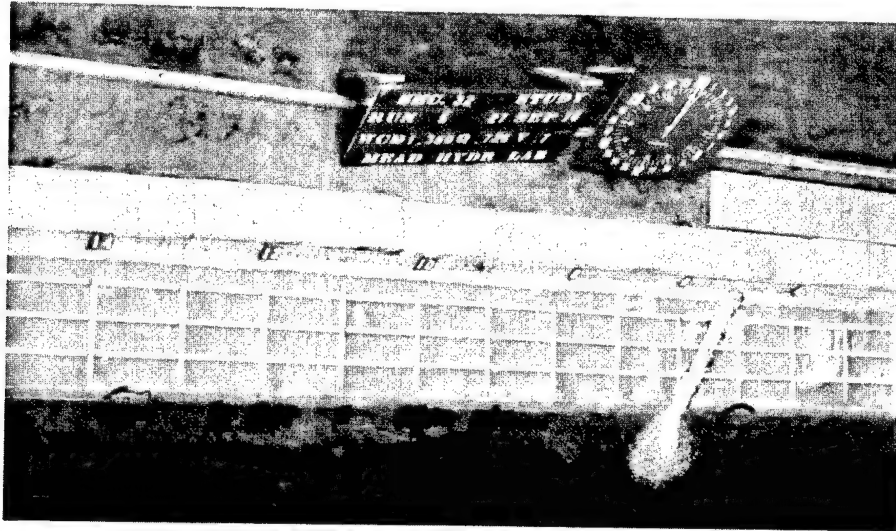
Photograph 10. Test bank arrangement prior to run 5.

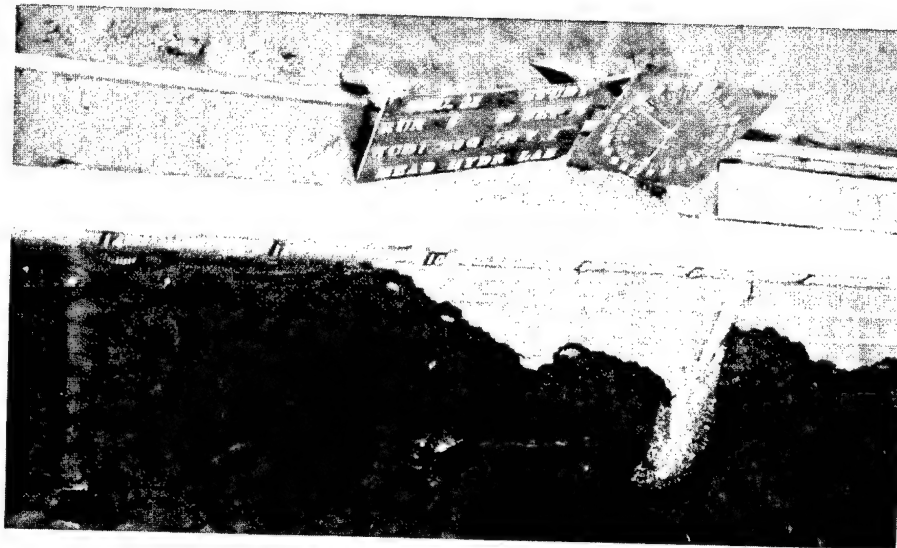
Photograph 11. Resulting channel bed and bank configurations at the end of run 5.

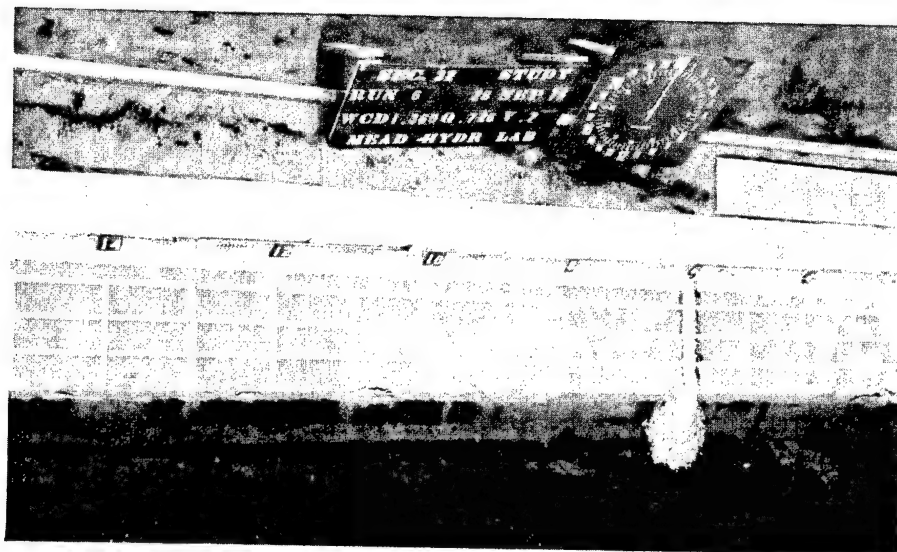
Photograph 12. Test bank arrangement prior to run 6.

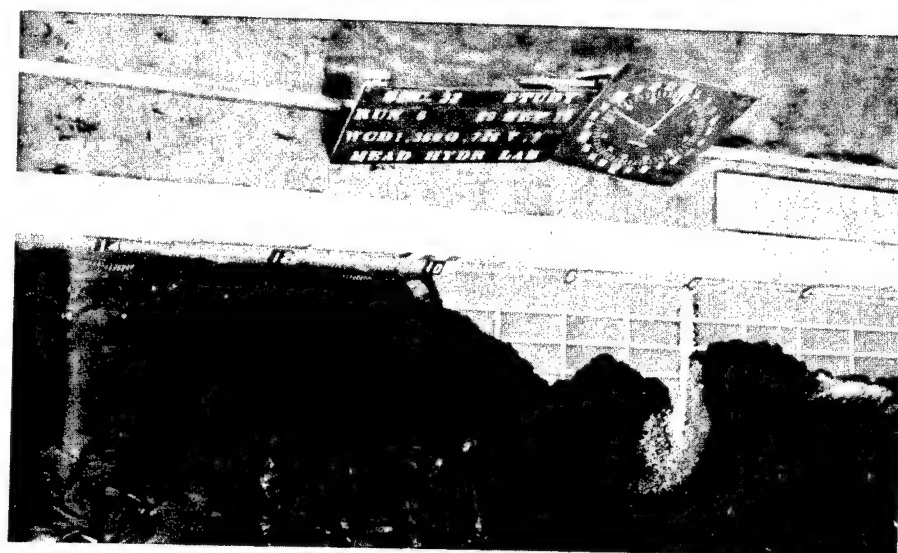
Photograph 13. Resulting channel bed and bank configurations at the end of run 6.

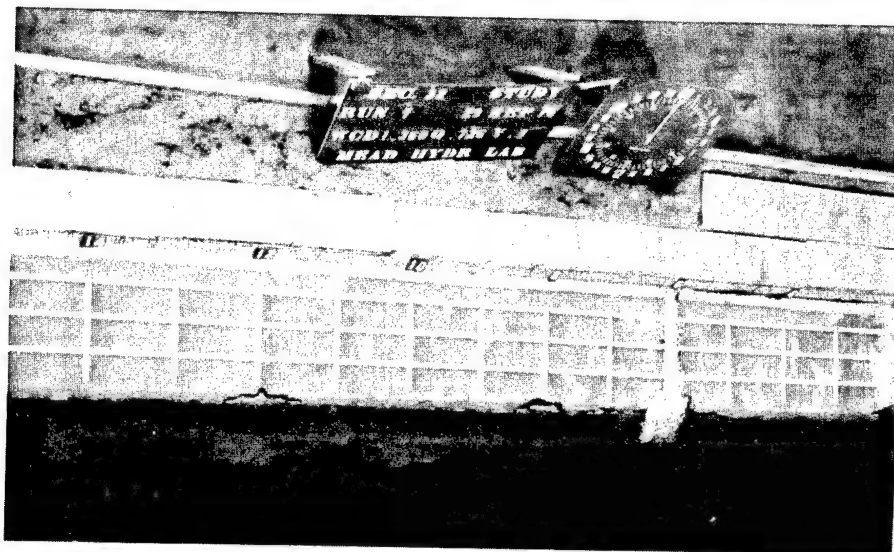
Photograph 14. Test bank arrangement prior to run 7.

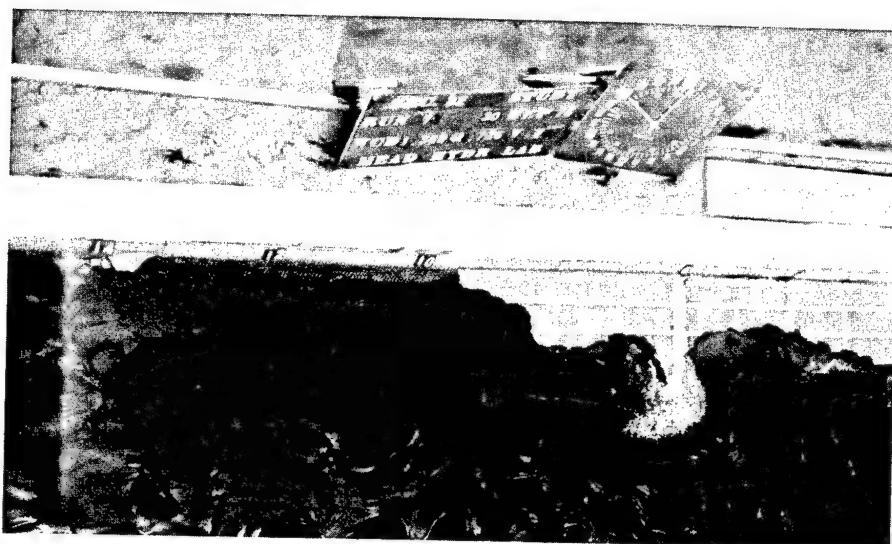
Photograph 15. Resulting channel bed and bank configurations at the end of run 7.

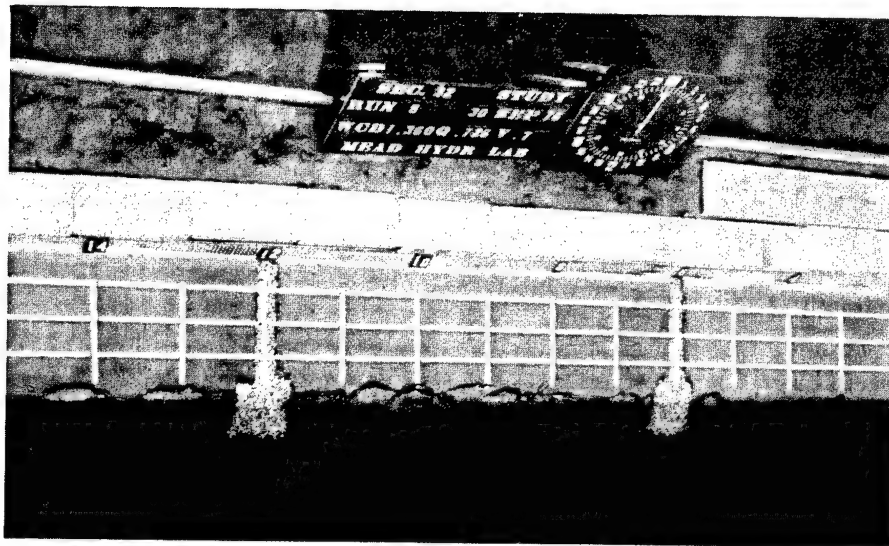
Photograph 16. Test bank arrangement prior to run 8.

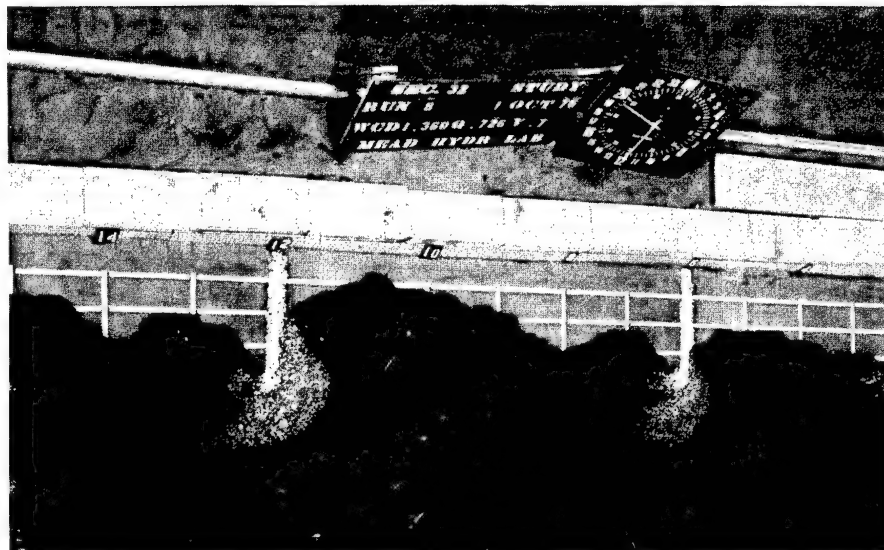
Photograph 17. Resulting channel bed and bank configurations at the end of run 8.

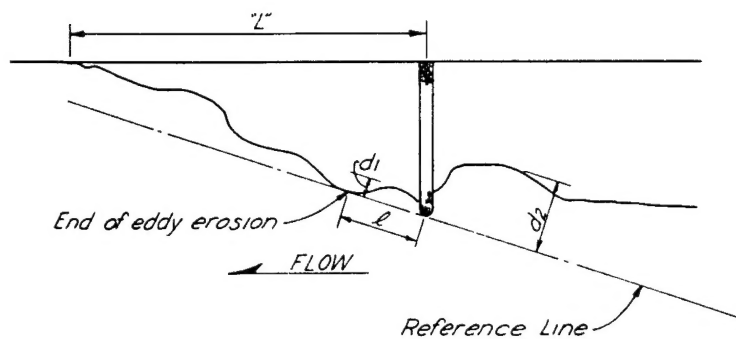
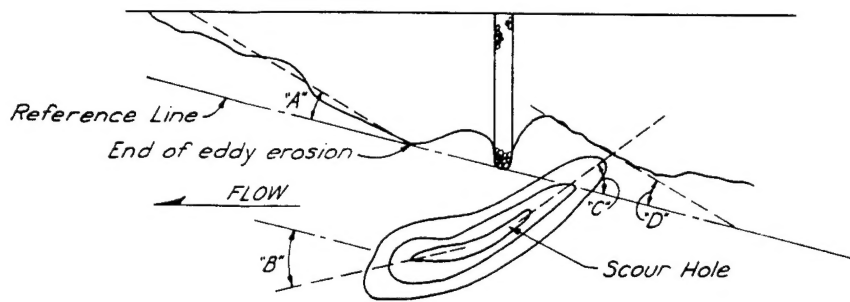
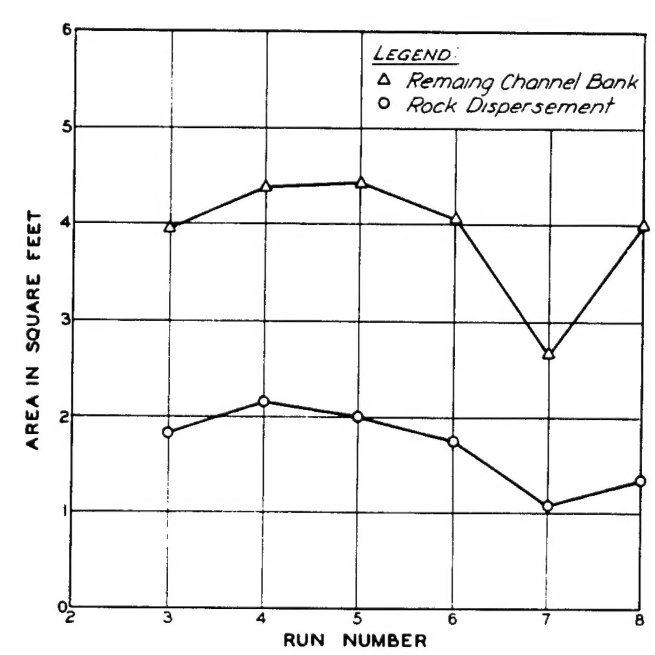
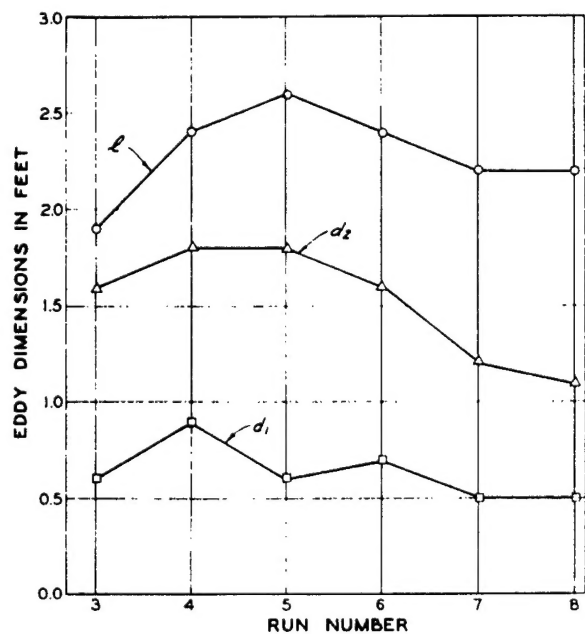
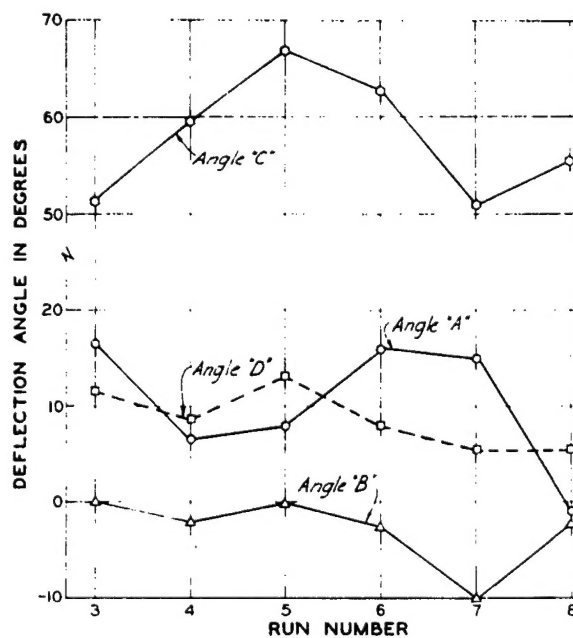
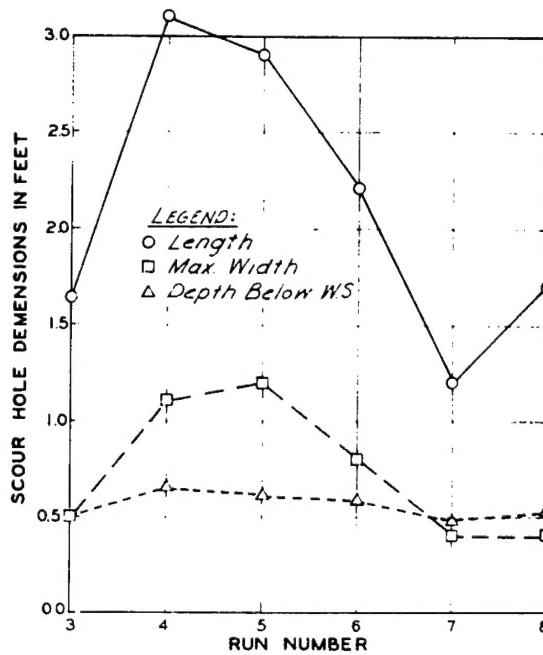
SECTION 32 DESIGN STUDY
 EROSION CONTROL USING HARD POINTS
 STRUCTURE EFFECTS ON LOCAL EROSION
 U.S. ARMY ENGINEER DISTRICT, OMAHA
 CORPS OF ENGINEERS OMAHA, NEBRASKA
 OCT. 1978

SCOUR HOLE DIMENSIONS IN FEET

The channel maps are contour charts of the channel bed. Reproductions of the channel maps are not shown in this report. These contour charts showed the general channel characteristics of size and shape of bed scour and the structure effects on local erosion. The scour hole contour maps were extracted from the channel maps to show local effects of the hard point structures. See plate 2. The data which were extracted from the scour hole contour maps were plotted on graphs so as to detect changes and evaluate trends associated with the different structure variations. See plate 3.

The slow-motion portion of the time-lapse movie indicated that the eddy areas were larger when the structures were placed 0.5 feet further riverward from the channel bank. These structures also had larger and deeper scour holes associated with them. See plate 2. The larger scour holes were created by the increased channel velocities caused by the constriction of the channel from the longer hard point structures. These longer structures had more area of hard point structure exposed to the flow in the channel and, consequently, used a larger amount of riprap to protect the underwater slope. See plate 2. Plots of scour hole lengths, widths, and depths downstream from the ends of the hard point structures are shown on plate 3. The bank erosion line and scour hole angles are also shown on plate 3.
